Chicora Research Contribution 552

Preservation Assessment of Tolson's Chapel Cemetery, Sharpsburg, Maryland

Prepared By:
Michael Trinkley, Ph.D.
and
Debi Hacker

May 1, 2013

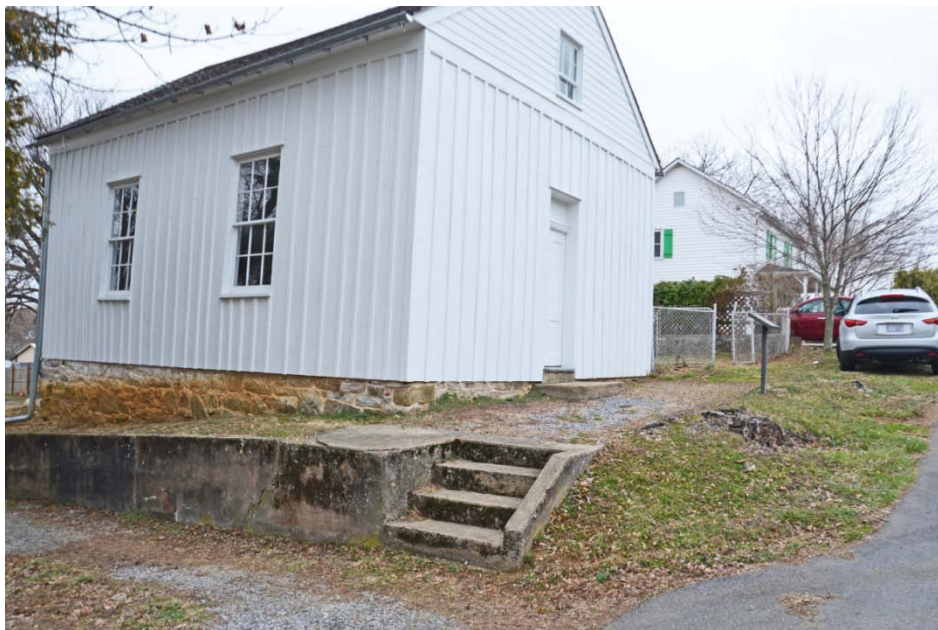
Figure 18. Steps and graveled walkway in front of Tolson's Chapel. Note also the limited parking area. The entrance gates are to the left of the parked automobile. View is to the northeast.

area in front of the double gates to the cemetery. The steps lack a handrail and the path is in poor condition. There is a small concrete step that provides access to the chapel's single width door projecting into the edge of the pathway.

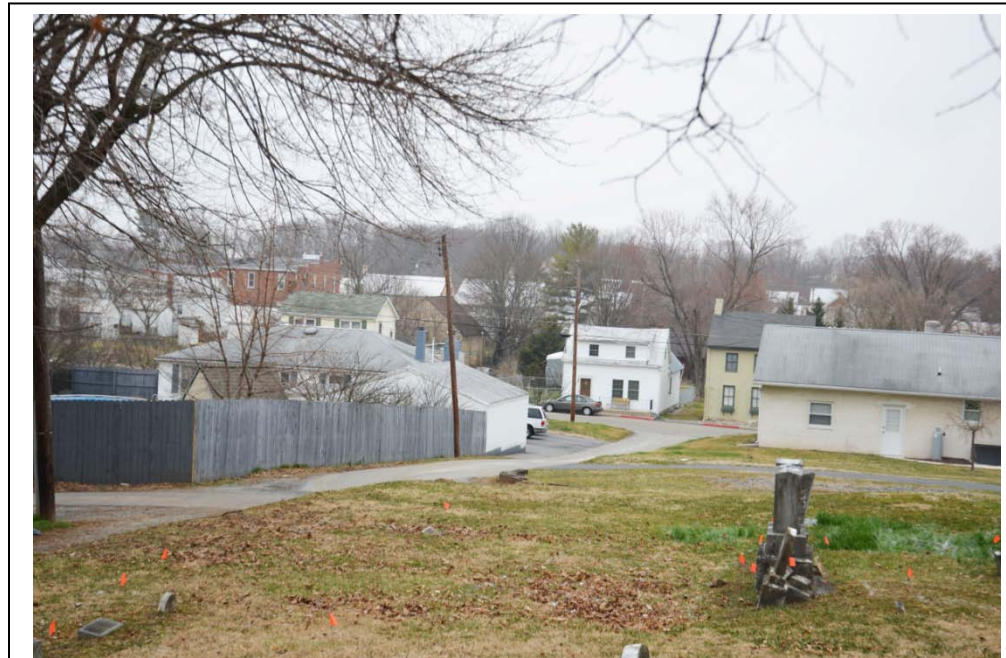
Figure 19. View from Tolson's Chapel Cemetery northward showing the slope and grassed condition of the cemetery.

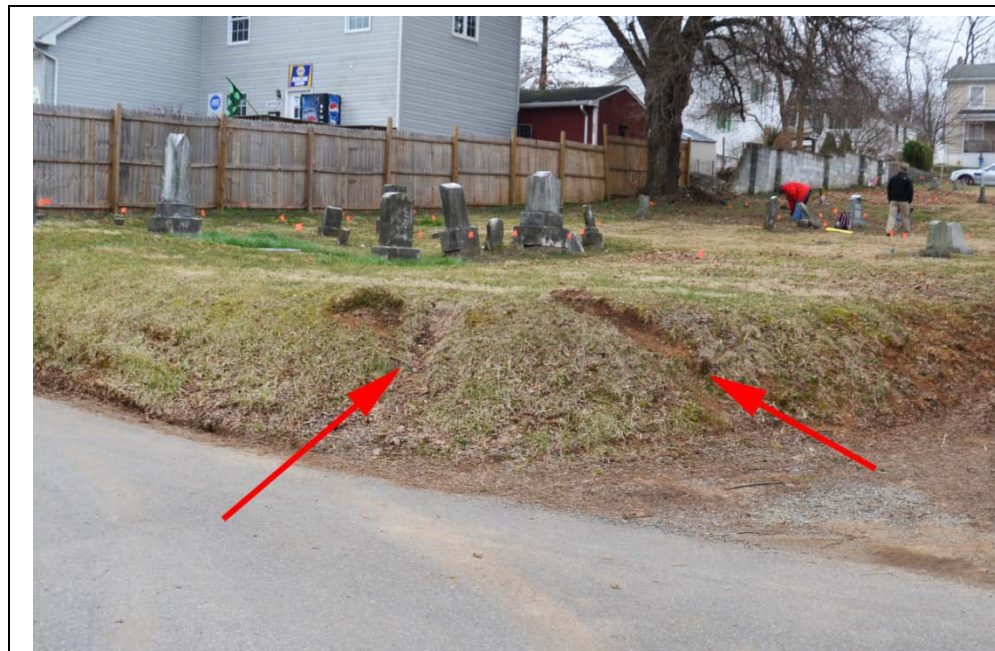
Figure 21. Rear of cemetery showing erosional areas caused by using the slope as a bike ramp. View is looking to the southeast.

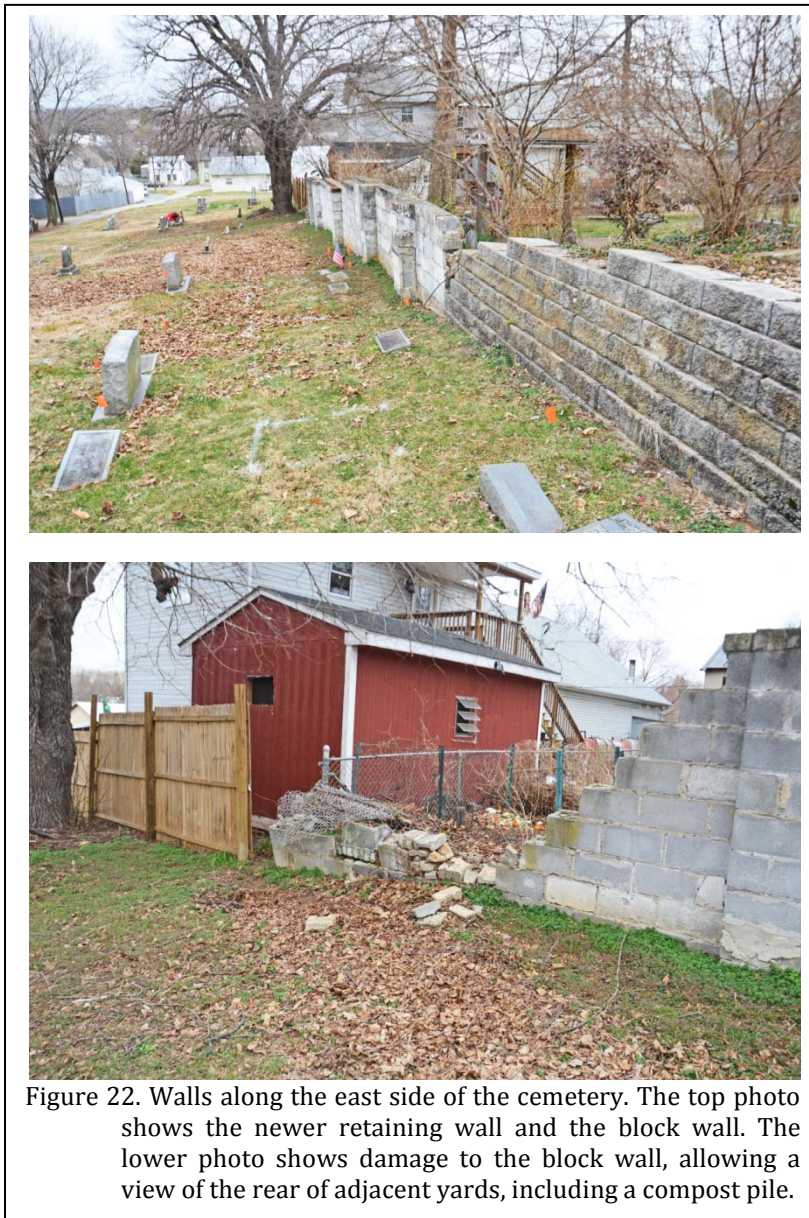
Figure 22. Walls along the east side of the cemetery. The top photo shows the newer retaining wall and the block wall. The lower photo shows damage to the block wall, allowing a view of the rear of adjacent yards, including a compost pile.

appropriate and do little to screen the cemetery from adjacent structures and activities. Structures to the north and west are not screened at all. This certainly affects the landscape character and visitor experience.

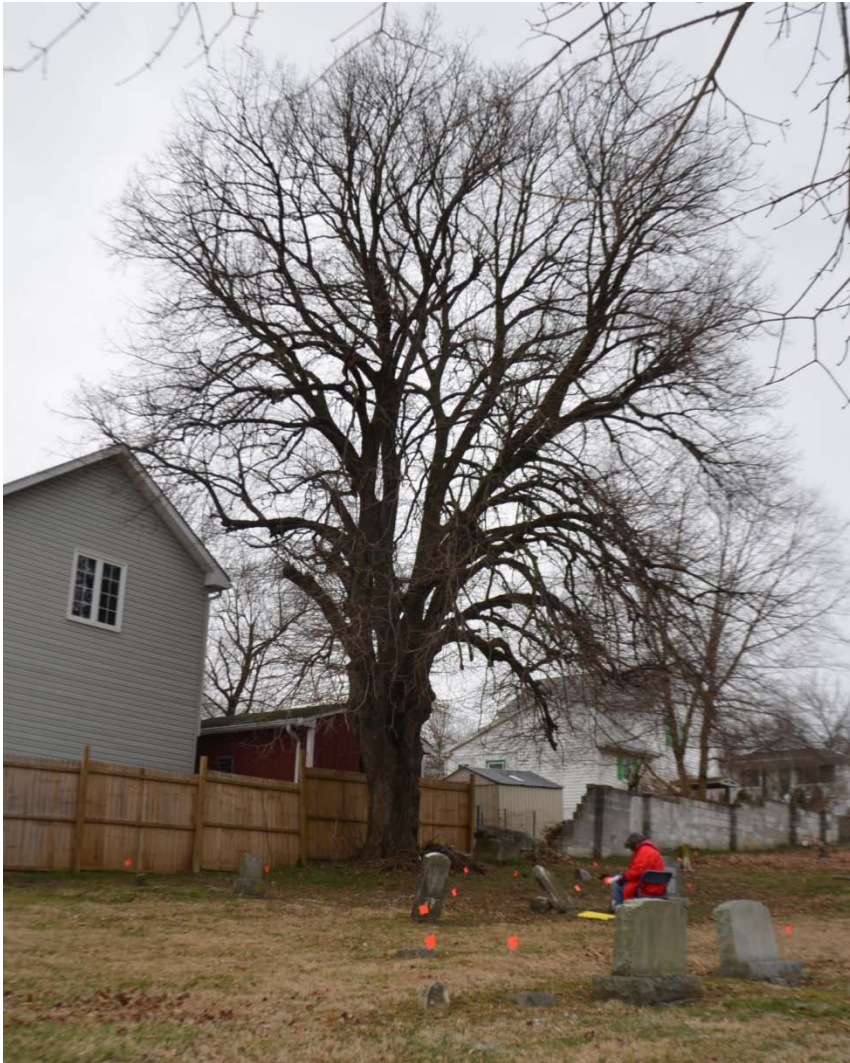
Figure 24. Maple along the east edge of the cemetery. Note damaged branches, crossed branches, and the need for pruning by a certified arborist.

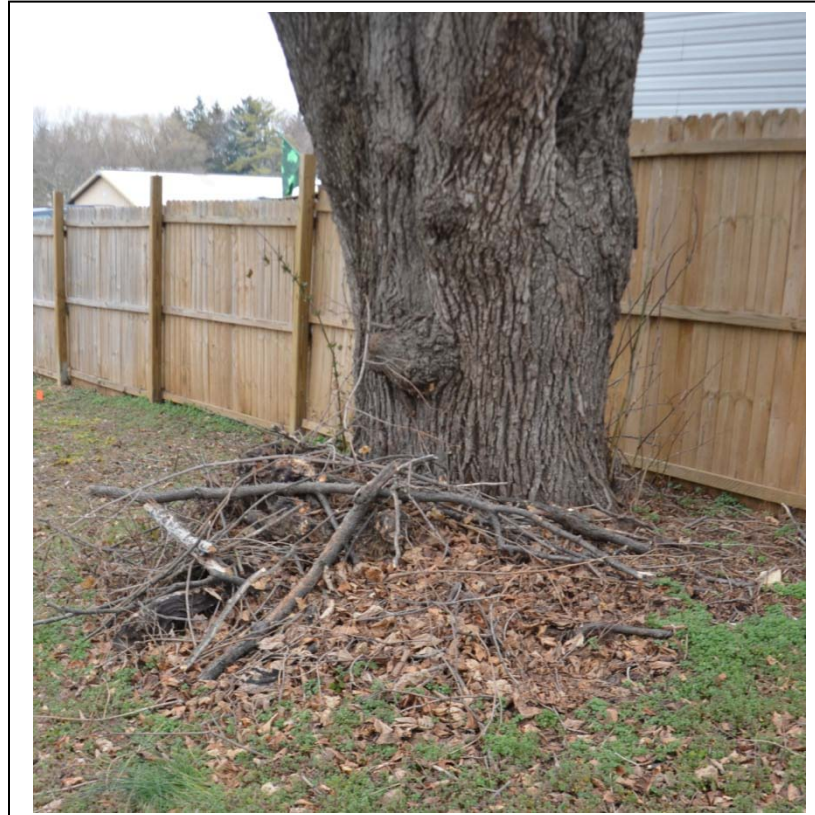
Figure 25. Branches and limbs stacked at the base of the maple should be immediately removed. Picking up and disposing of downed branches should be part of every mowing.

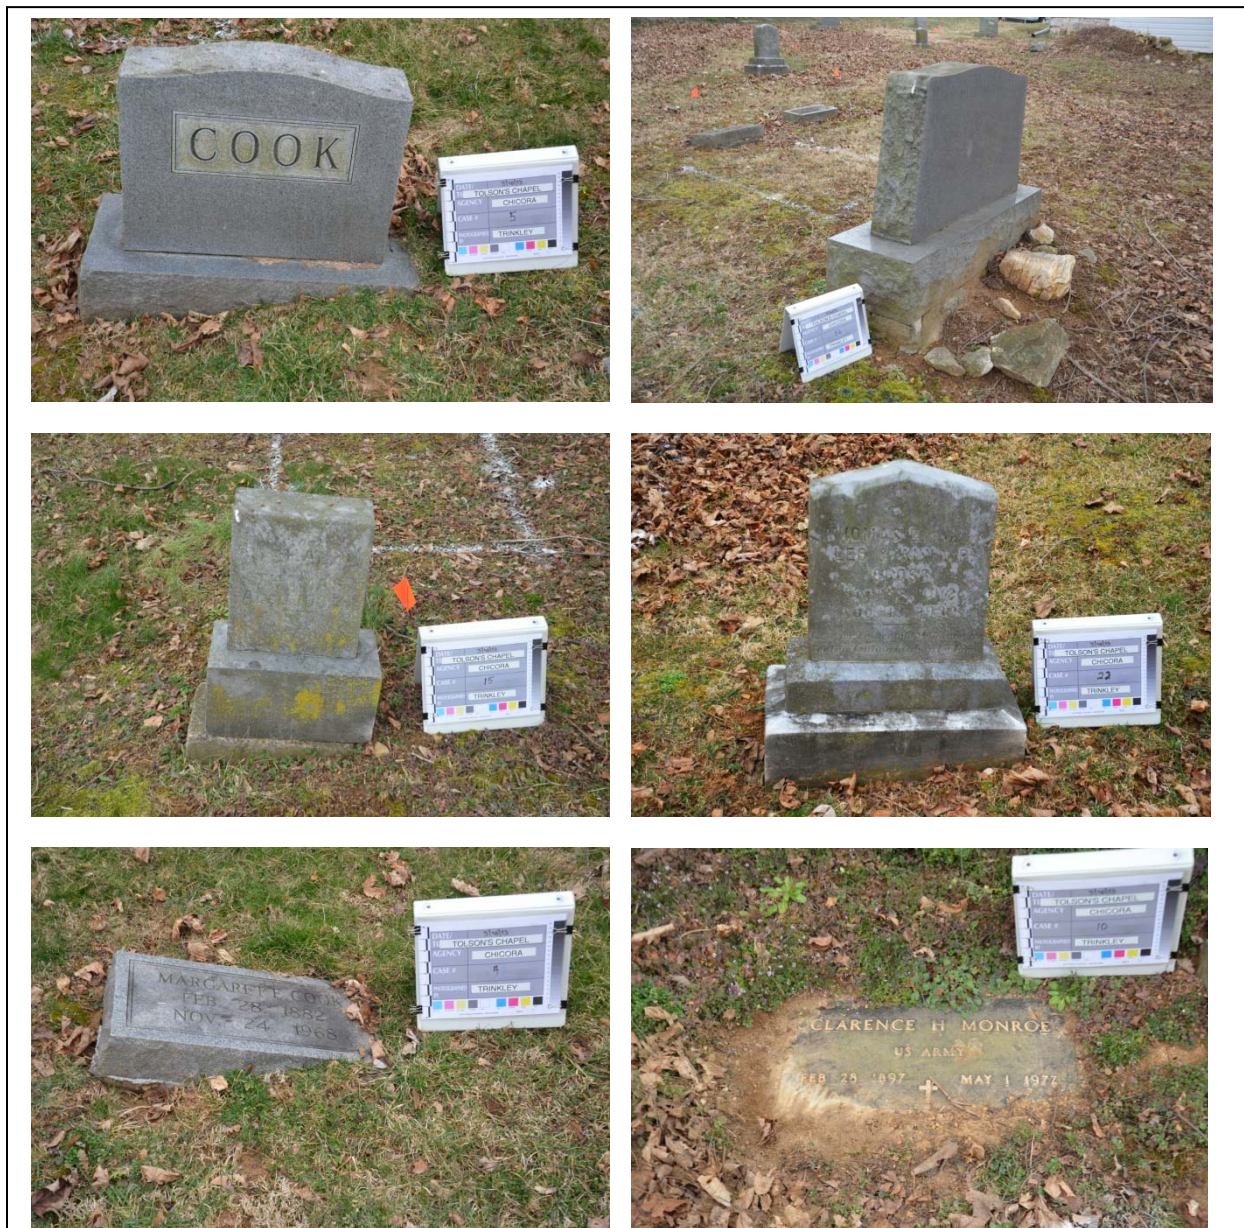
Figure 33. Examples of conservation issues at the cemetery. The upper row shows granite die on base monuments that require resetting. When the stone is tall, top heavy, or may be subject to vandalism, it is appropriate to drill the die and base for the use of a pin. The middle row illustrates two similar marble die on base monuments which may have ferrous pins. The lower row illustrates two lawn markers – one granite, the other bronze – that require resetting to level them.

and filled with pea gravel or decomposed granite as bedding. The lawn marker should be reset about 1 inch above the ground level – tall enough to prevent being covered by soil and grass, but not so tall that it will be damaged by mowing. Additional pea gravel should be packed in around the stone as it is being leveled. The upper inch of backfill should be soil to allow for revegetation.

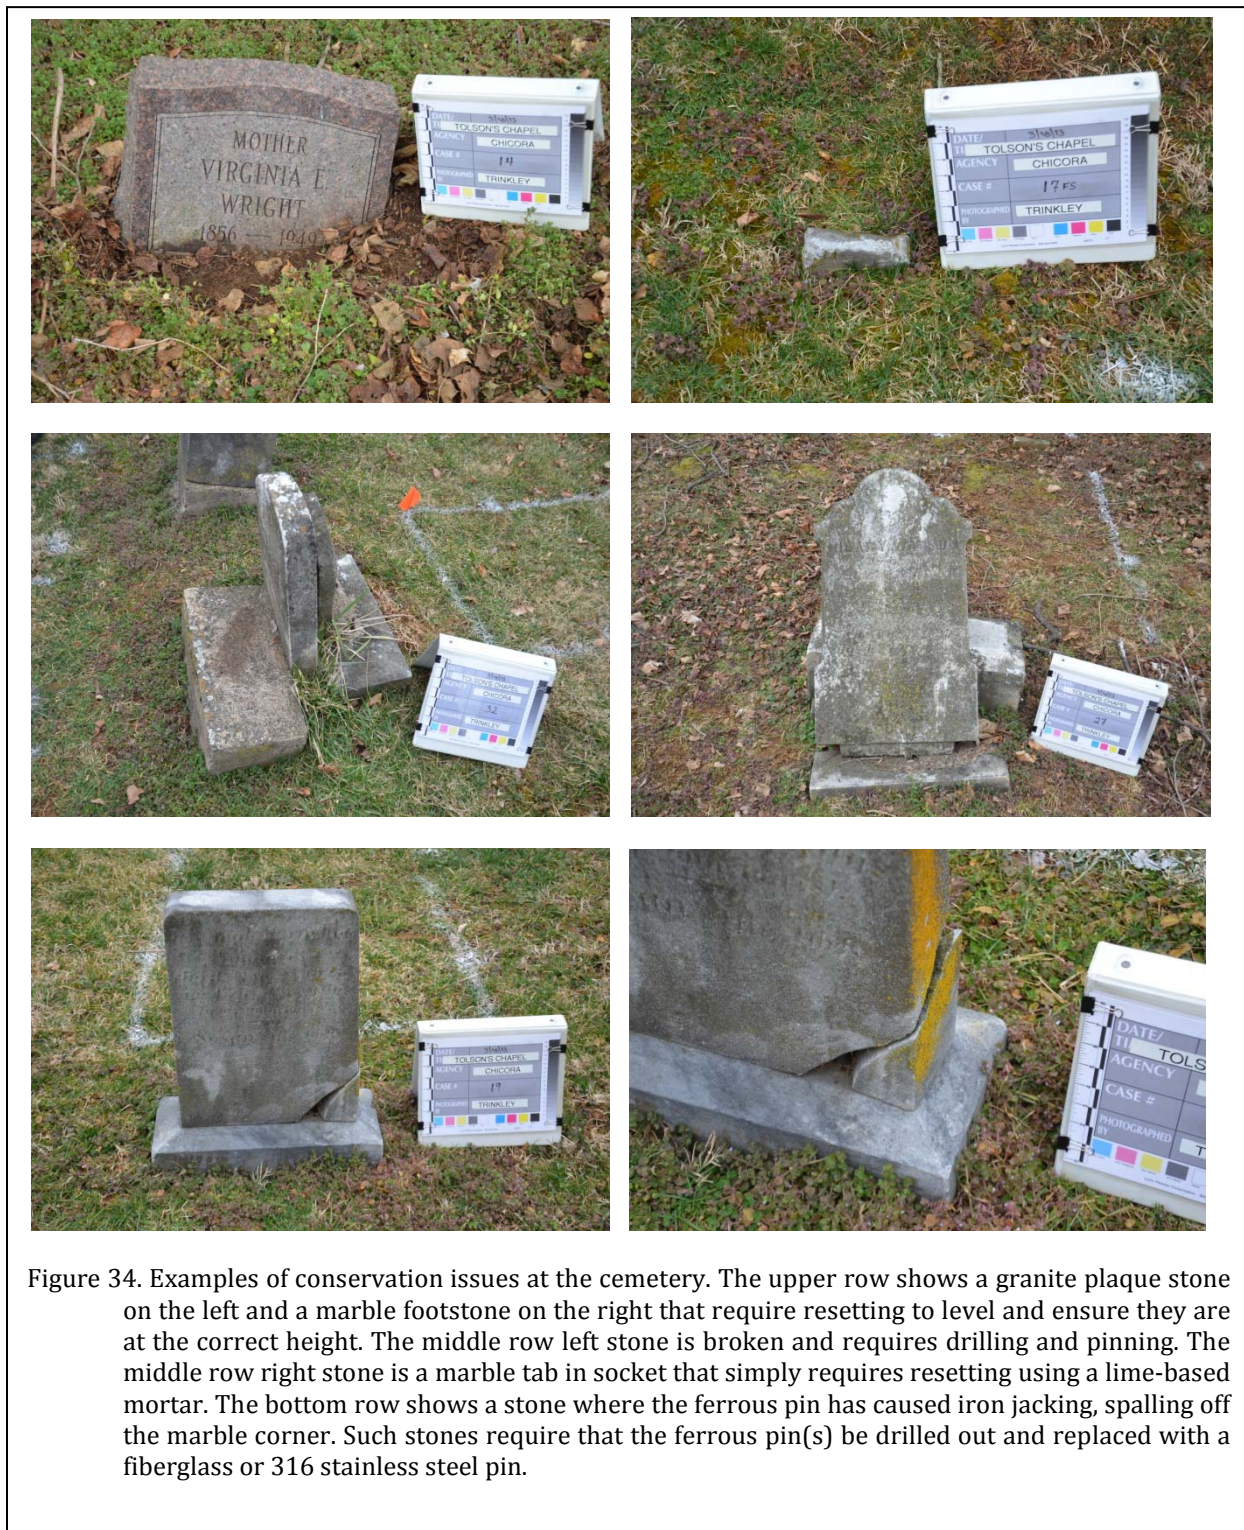
Some die on base stones were observed that had been set using ferrous pins to join the die and base. These stones should be given a high treatment priority since, left untreated, the corrosion of the ferrous pin will cause significant spalling, cracking, and breakage of the stones – a process known as “iron jacking.” The corrosion products of these ferrous pins have a greater volume than the original pin and as the corrosion products expand, they crack the stone.

Figure 34. Examples of conservation issues at the cemetery. The upper row shows a granite plaque stone on the left and a marble footstone on the right that require resetting to level and ensure they are at the correct height. The middle row left stone is broken and requires drilling and pinning. The middle row right stone is a marble tab in socket that simply requires resetting using a lime-based mortar. The bottom row shows a stone where the ferrous pin has caused iron jacking, spalling off the marble corner. Such stones require that the ferrous pin(s) be drilled out and replaced with a fiberglass or 316 stainless steel pin.

It is necessary to use diamond core drills to remove the corroded ferrous pins and replace them with either fiberglass or, rarely, stainless steel. Afterwards it is necessary to fill the voids with a natural cementitious composite stone material such as that previously described for infill repairs.
